# Near-Term Improvements

## 5.1 Introduction

A central goal of the Kenilworth Avenue Corridor Study is to provide safe and convenient pedestrian and bicycle access throughout the neighborhoods of the Kenilworth Avenue Corridor. Since these types of improvements can be implemented quickly at little cost, they tend to be the predominant recommendations for near-term improvements in the corridor.

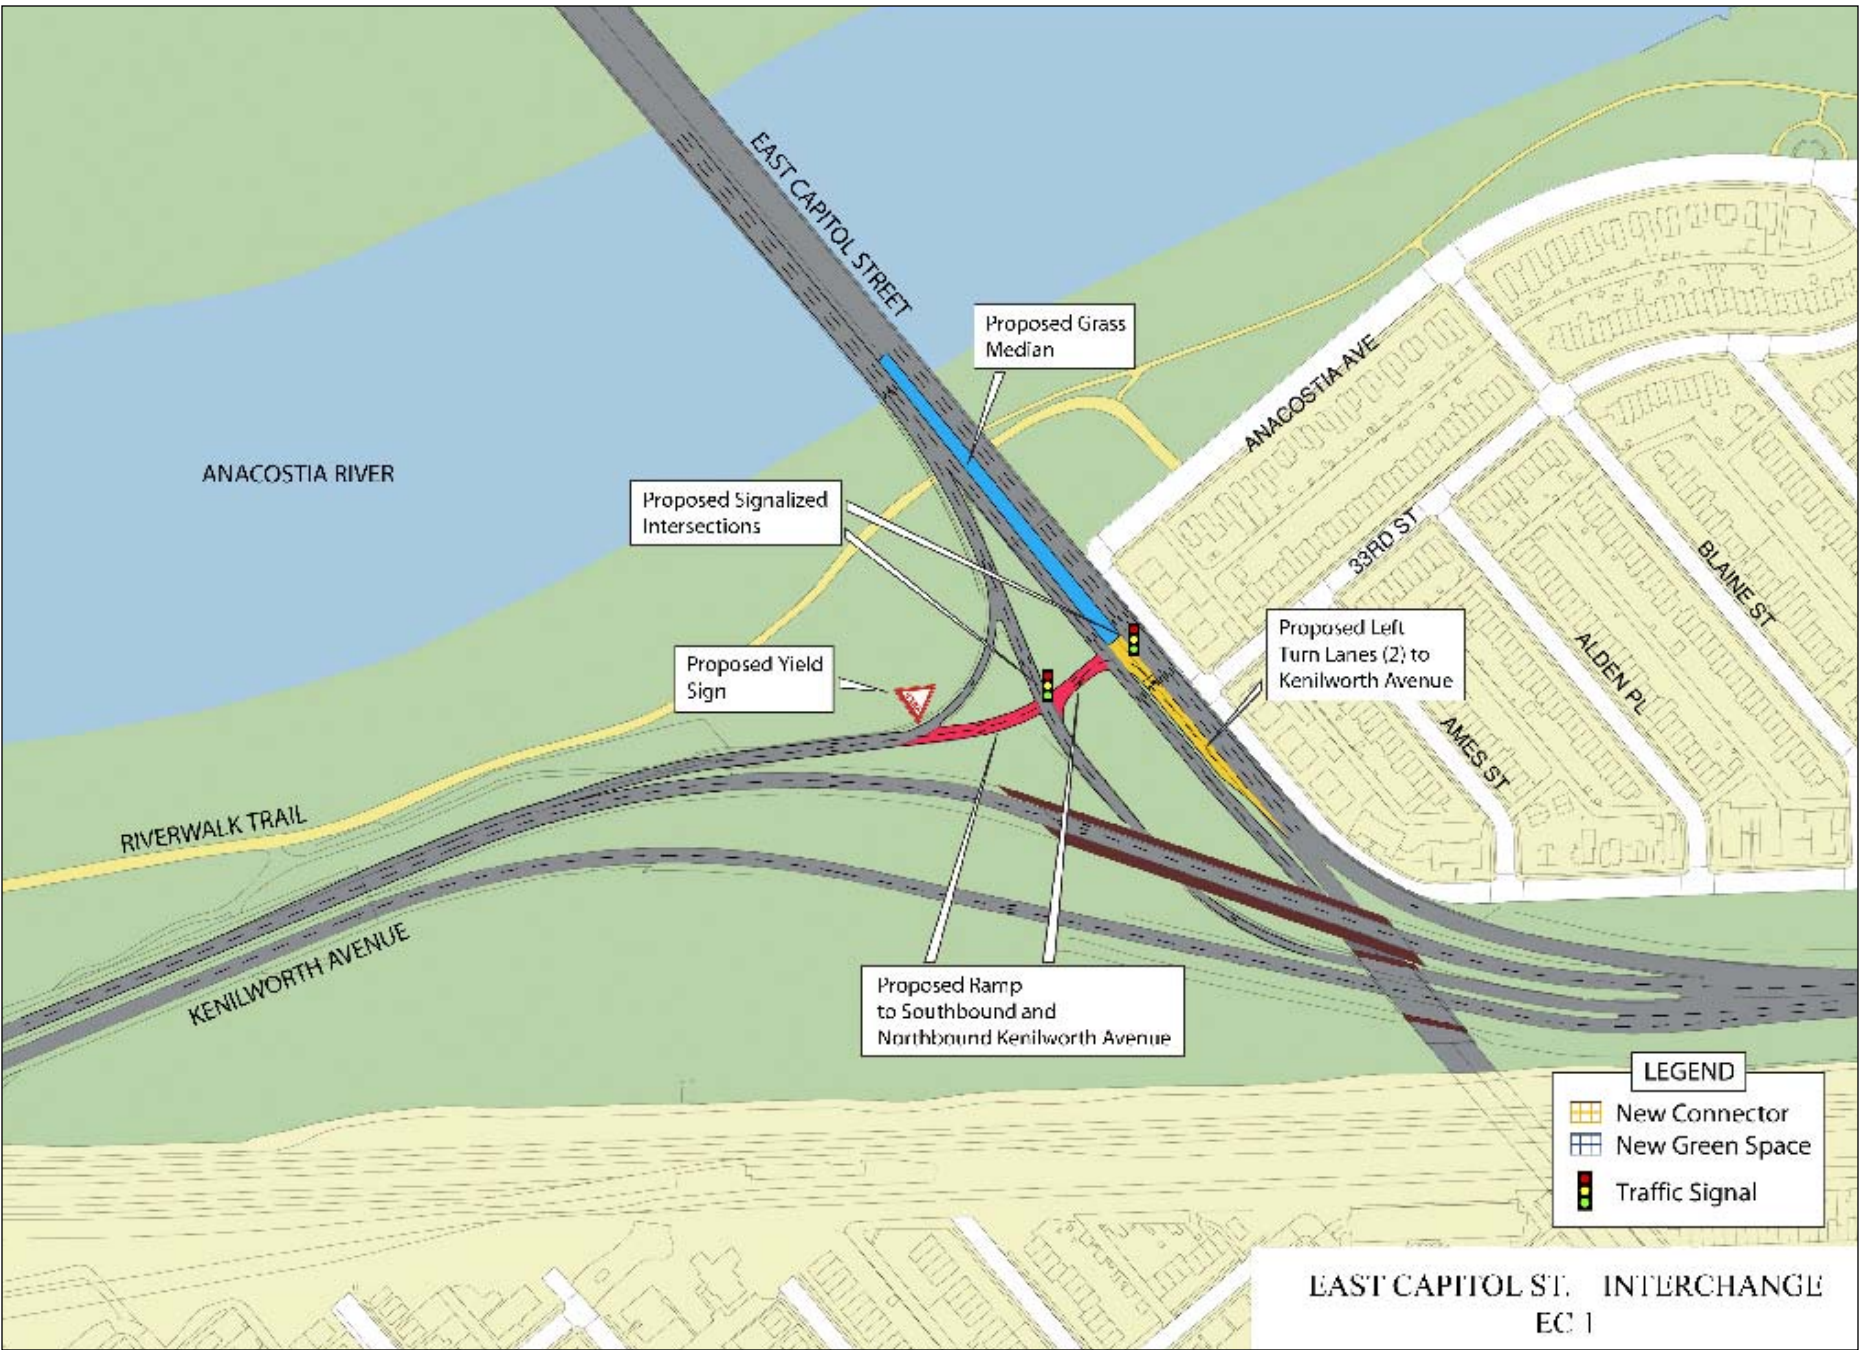
Figure 5.2: East Capitol Street Scenario EC-1

A new connection is made to allow traffic on westbound East Capitol Street to exit southbound and northbound onto Kenilworth Avenue. A new connector is constructed just west of Kenilworth Avenue at a 90° angle to East Capitol Street. This new connector intersects and crosses the existing exit ramp for eastbound East Capitol Street to northbound Kenilworth Avenue. After it crosses the northbound exit ramp, it merges with the southbound ramp from eastbound East Capitol Street.

This project requires that East Capitol Street be widened just west of Kenilworth Avenue to allow construction of two left-turn lanes onto the new connector. It also requires new traffic signals at the connector intersection with East Capitol Street, and at the intersection of the new connector with the exiting northbound exit ramp from eastbound East Capitol Street. Minor modifications are required to the existing southbound and northbound ramps to accommodate the new connector.

This project is an intermediate step to providing full movement at this interchange. After Scenario EC-1 is complete, building Scenario EC-2 completes the interchange to allow all movements. No pedestrian or bicycle improvements are included.

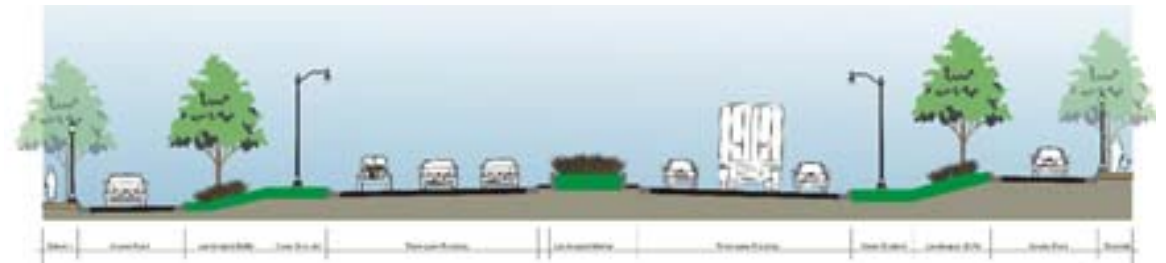
**Figure 5.5: Cross Section B**

Three lane Kenilworth Avenue with landscaping between the mainline and service lanes, and a landscaped median.

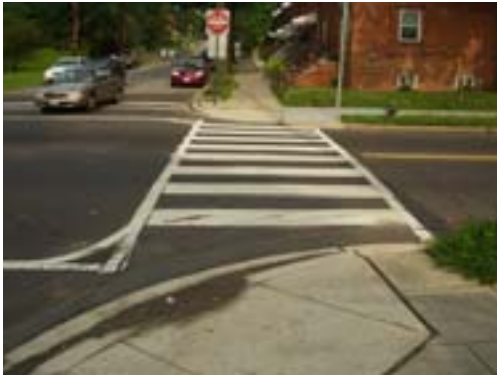
Crosswalks should be marked with high-visibility thermoplastic markings like those striped across 44th Street at Gault Street, NE.

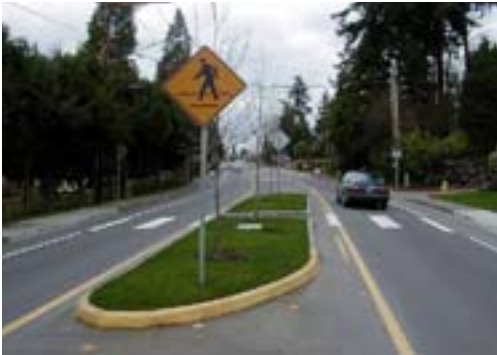
Adding median islands at several important crosswalks can reduce motor vehicle speeds and make it easier for pedestrians to cross one direction of traffic at a time (right).

- **Pedestrian Crossing (Median) Islands:** Pedestrian crossing islands allow pedestrians to cross one direction of motor vehicle traffic at a time.

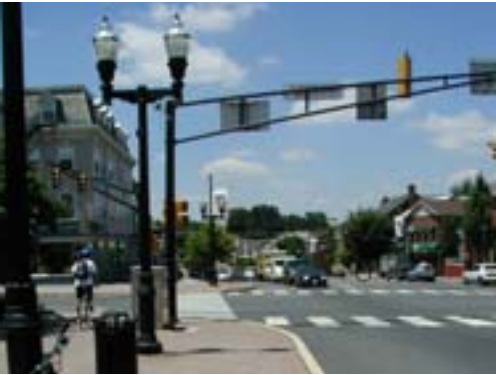
Intersection lights should be of a pedestrian scale and illuminate all crosswalks at an intersection.

- **Roadway Lighting:** Improving roadway lighting reduces nighttime pedestrian crashes and shall illuminate all pedestrian crosswalks and be of a pedestrian scale.
- **Pedestrian Signals:** Provide pedestrian signals heads at all intersections that have traffic signals so as to indicate clearance time for pedestrians to complete crossing the street.

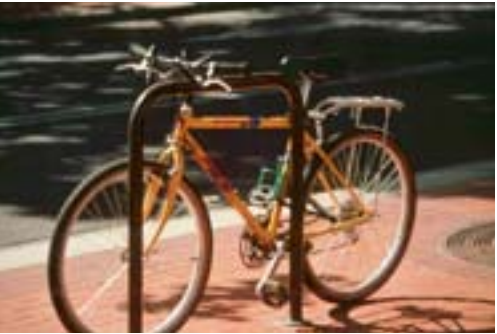
U-shaped bicycle racks provide short-term bicycle parking at train stations, bus stops, stores, parks, schools, and other locations.

- **Bicycle Racks:** Bicycle racks provide short-term bicycle parking in locations that are convenient to stores, parks, bus stops, and transit stations. Bike racks are currently provided at the Minnesota Avenue and Deanwood Metrorail Stations; however, they are not within view of the station manager. Coordinate with WMATA to study relocating bicycle racks inside both of the stations to help deter bicycle theft. Install small bicycle racks at bus stops, schools, parks, and store entrances in the corridor (requires coordination with WMATA, the National Park Service, and retail businesses).

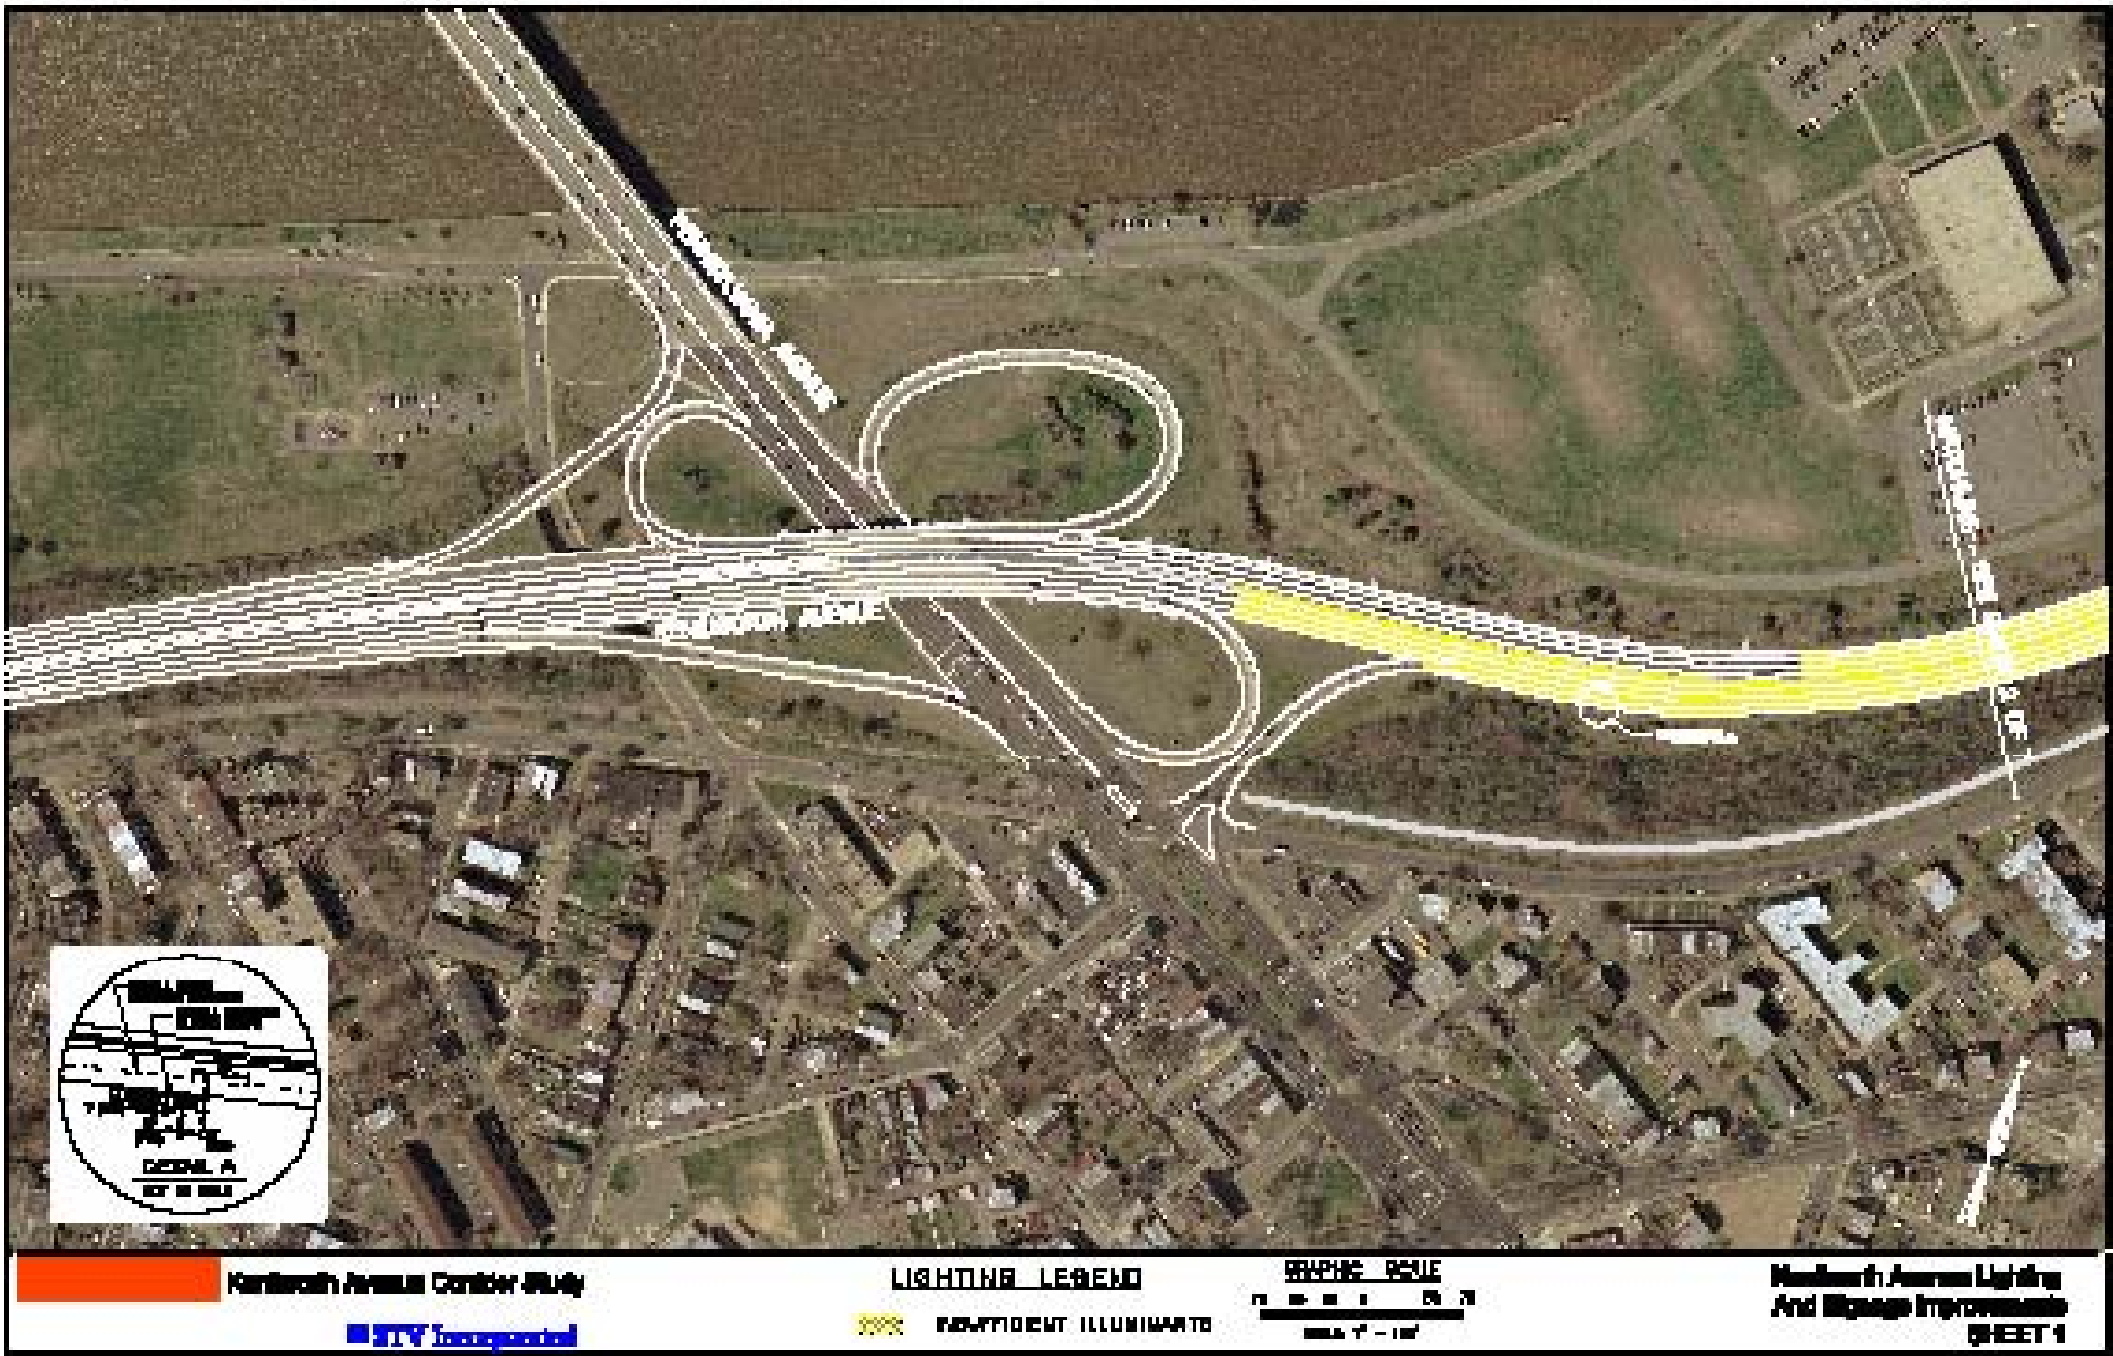
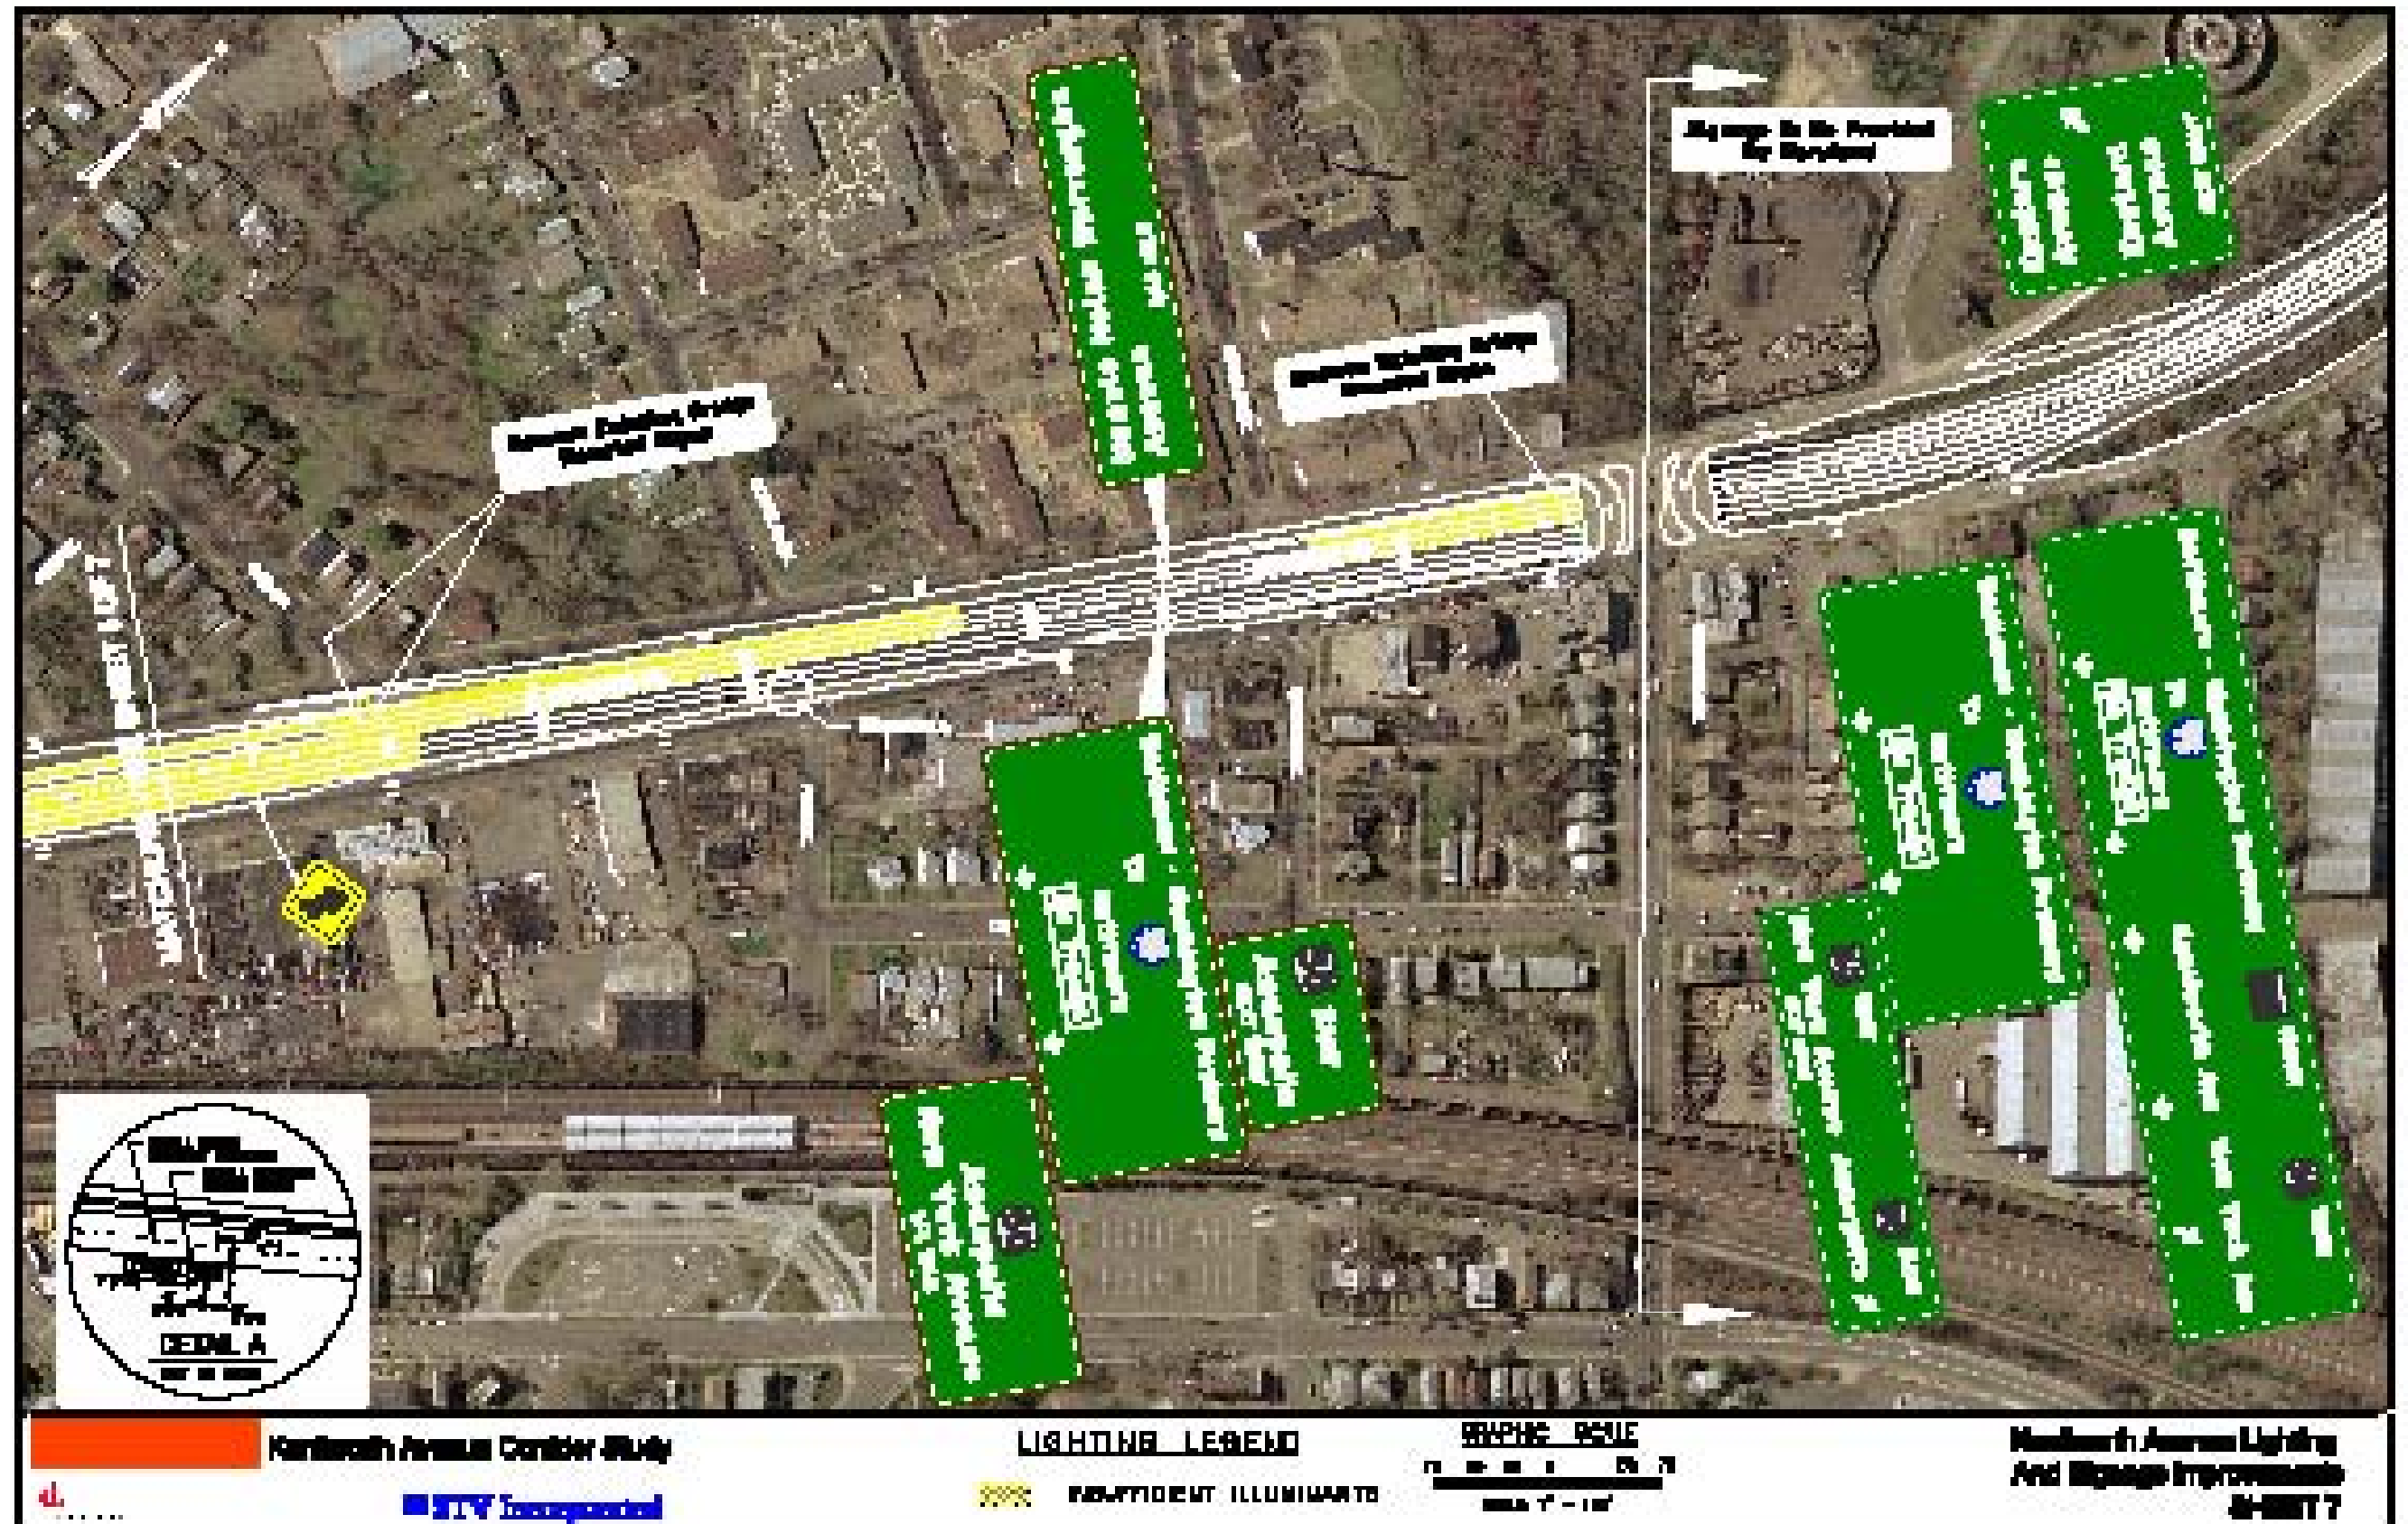
In the Near-Term, additional lighting will be installed throughout the corridor in the locations where lighting is lacking and where levels were found to be inadequate. This includes providing lighting under Kenilworth Avenue at Nannie Helen Burroughs Avenue. Lighting would also be installed for the weaving section under Benning Road. The proposed light pole locations are shown on Figure 5.8.

enter northbound Kenilworth Avenue at the Benning Road weaving section. Near Term signing improvements are shown in Figure 5.8.
